Inspection Report
Minerals Regulatory Program
Date: March 13, 2009

Mine Name: Yellow Hammer	Permit Number: M/045/0019
Operator Name: American Consolidated Mining	Inspection Date: 06-11-2008
Inspector(s): L Heppler	Time: 4:00 PM
Other Participants: none	Mine Status: RET

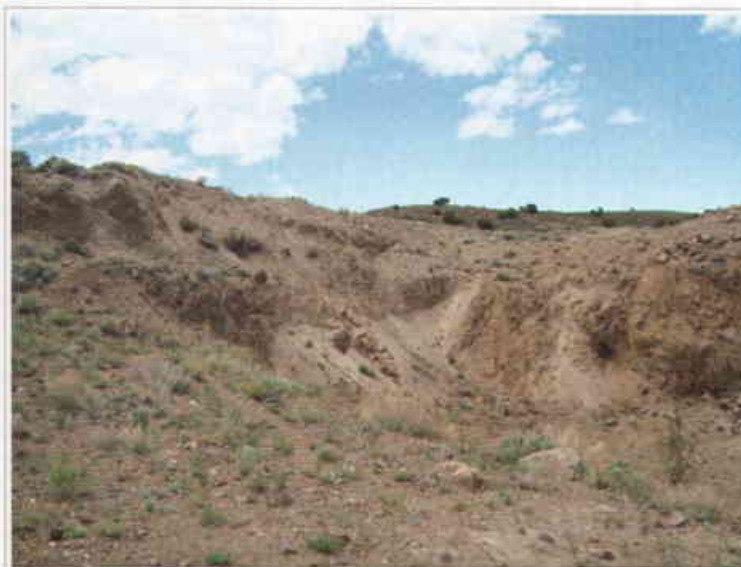
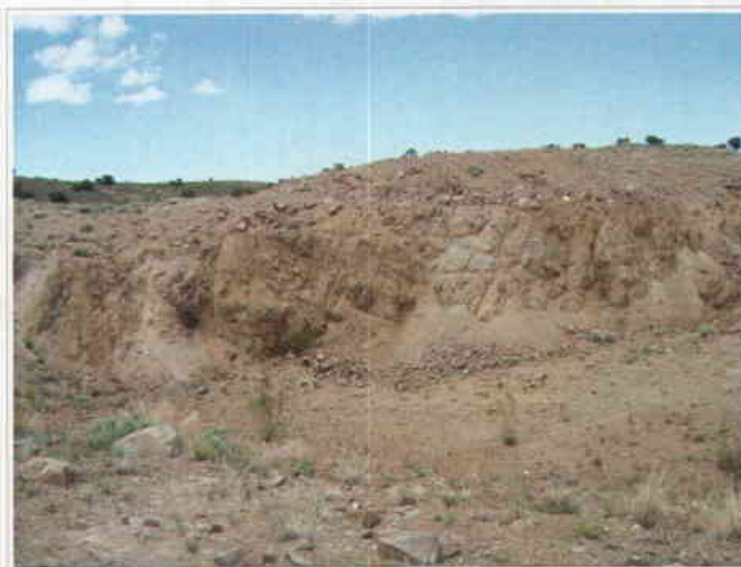
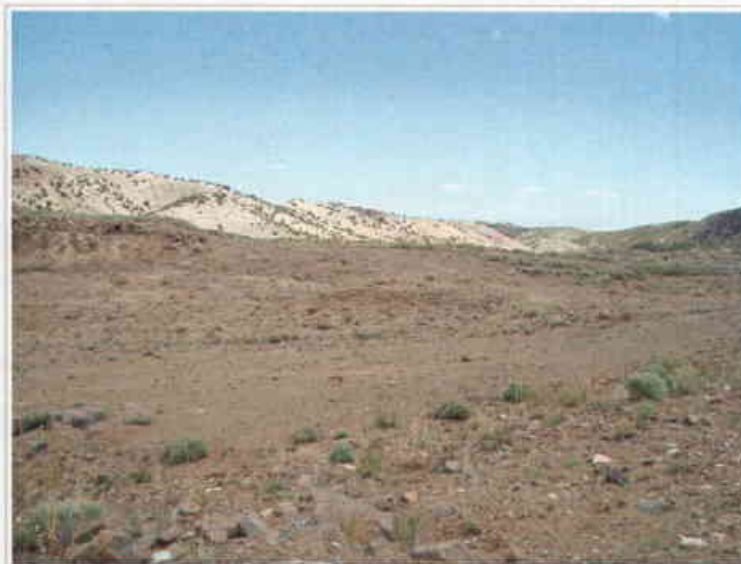
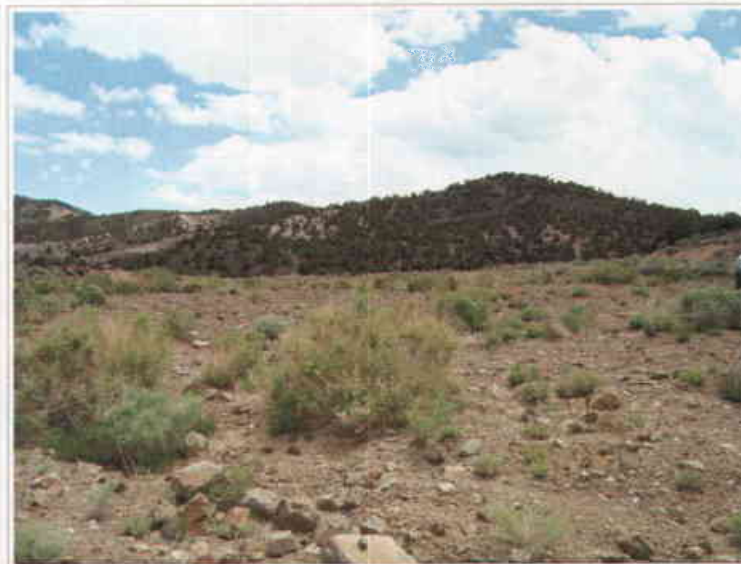
Inspection Summary: This site has been reclaimed. I was checking on the site vegetation growth.

Photos were taken to document site conditions.

Conclusions and Recommendations: OGM to continue annual inspections and monitor the site when in the area.
